May 6, 2025

MIR-25-19

## Grounding of Towing Vessel *City of Louisville*

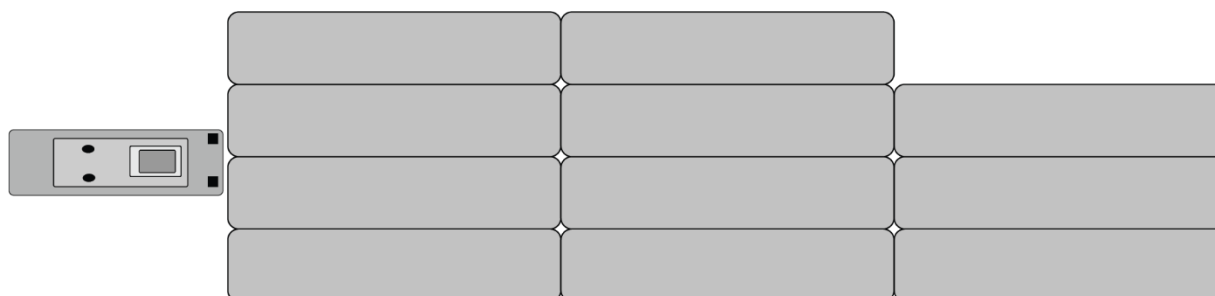
**Figure 3.** *City of Louisville* tow arrangement (scale approximate).

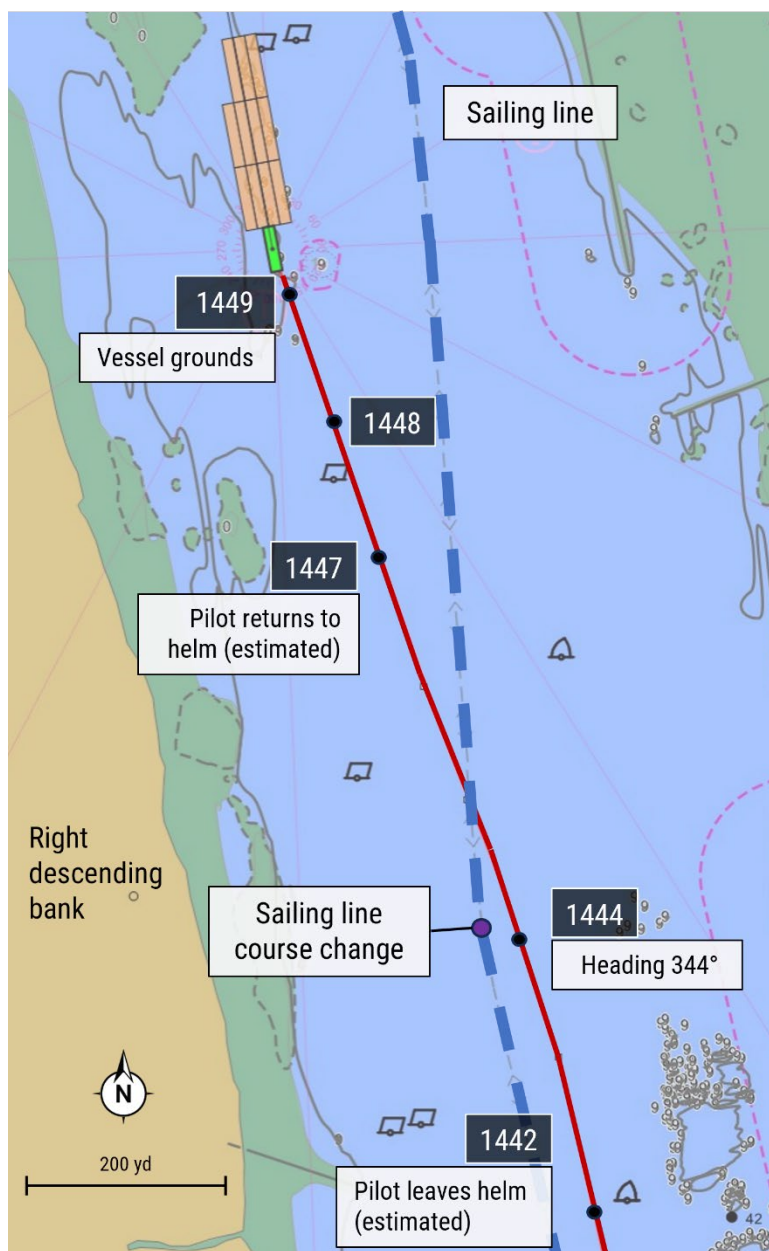
At 1444, on a heading of 344° at 4.7 mph, the *City of Louisville* tow passed a point where the sailing line changed course from 347° to 356°. About a minute later, the tow crossed over the sailing line on a heading of 346° at 4.8 mph (see figure 4).

**Figure 4.** ECS showing the positions of the *City of Louisville* for 7 minutes before the time of grounding. (Background source: US Army Corps of Engineers chart U37UM000 as viewed on Rosepoint)

door of the wheelhouse; he estimated that he returned to the helm at 1447. At that time, the boat was about 95 yards west of the sailing line on a heading of 346° at 4.8 mph. He noticed the tow was making a “sharp” turn to port, which he attempted to correct by putting the steering rudders to 30° to starboard (no change was made to the propulsion control levers). The head of the tow began to swing to starboard. The stern swung to port in the direction of the right descending bank, and, at 1449, the vessel grounded in a rocky area about 150 yards west of the sailing line (see figure 5).<sup>5</sup> The vessel was reported to have about 8 feet of draft at the time of the casualty; river conditions at that time were low with the river gage nearest to the casualty site at 7.4 feet (Upper Mississippi River mile 43.7).

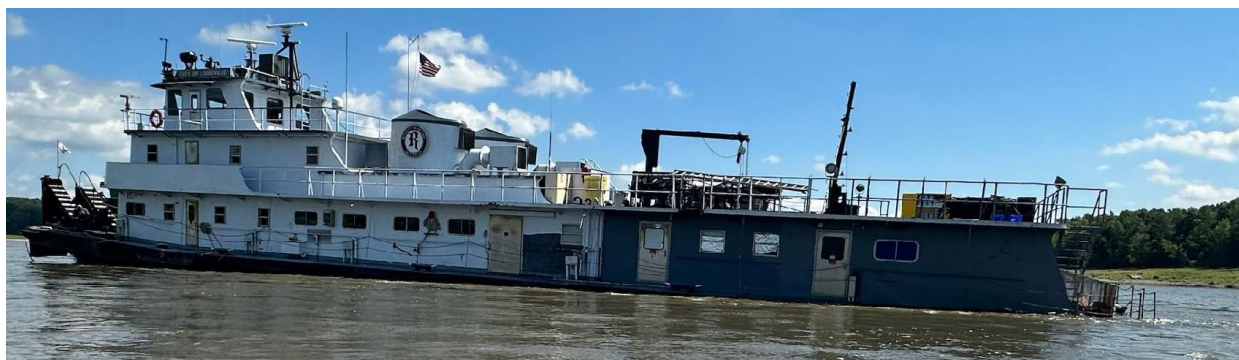
The hull of the *City of Louisville* was breached, and water flooded into the engine room, causing the vessel to settle to the bottom. There were eventually about 4 feet of water in the lower engine room. The tow remained intact, facing upriver after the grounding. The pilot said they were unable to move the vessel off the rocks.

About 3 hours after the grounding, at 1753, thunderstorms passed through the area, which required the crew and responding personnel to evacuate the *City of Louisville*. Winds from the storm moved the tow to starboard, causing it to pivot on the rocks; the tow was then oriented toward the left descending bank. As the river stage later rose, the water level inside the engine room increased, and the main deck rudder room and aft galley/mess area also flooded.

**Figure 5.** The *City of Louisville* aground. (Source: Coast Guard)

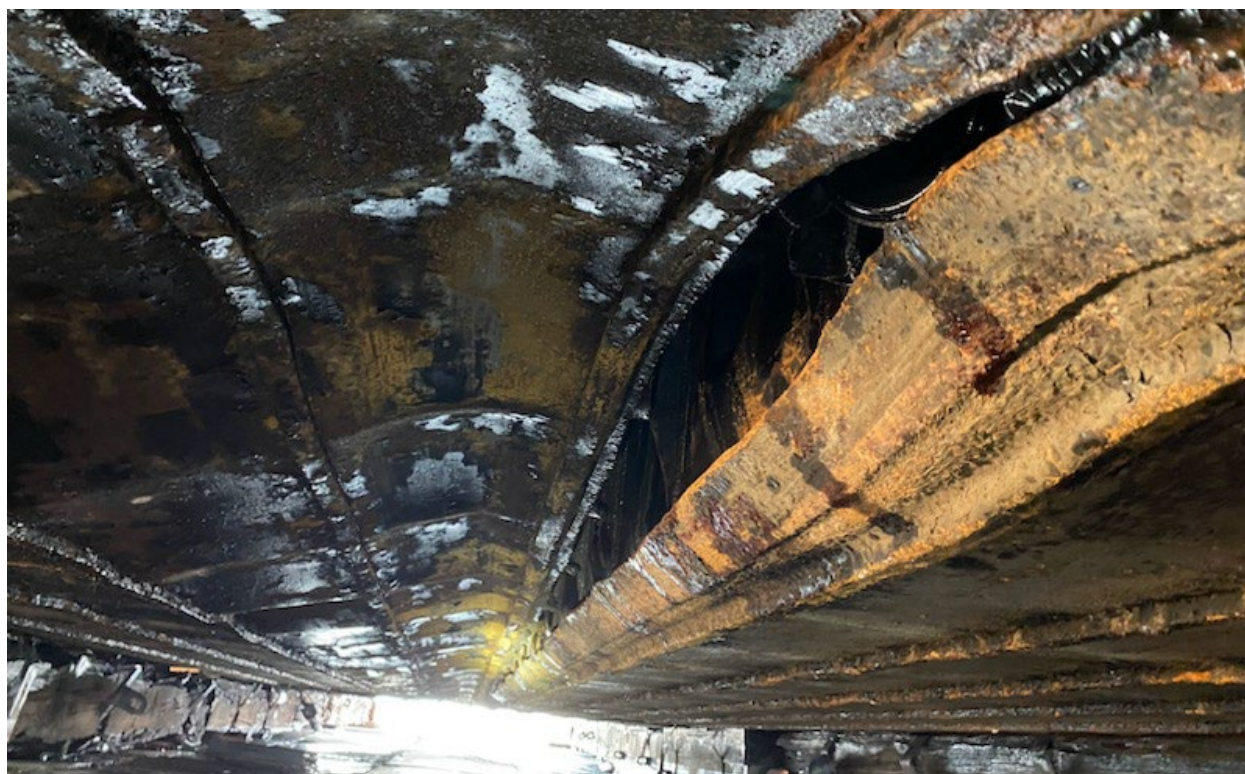
A marine survey documented hull fracture damage to the bottom plating of the main engine room space about 4 feet forward of the aft watertight bulkhead to the propeller shaft alley (see figure 6). Damages to the shell plating varied, with the most prominent being to port of the vessel's keel. Hull plating was set up into the engine room to about 14 inches in areas. Numerous fractures, distortions, and insets were found along the bottom plating extending in three primary surface areas of about 9 feet long by 14 feet wide, 29 feet long by 4 feet wide, and 6 feet long by 8 feet wide.

**Figure 6.** The aft port side (looking forward) bottom shell plating damage of the *City of Louisville* while in dry dock. (Source: Coast Guard)
